Skaneateles Lake Watershed Composting Toilet Project

Rich Abbott

Abstract:

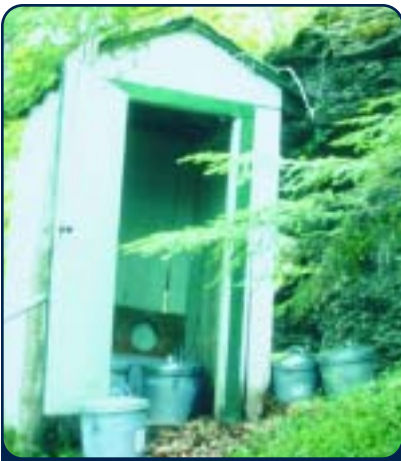
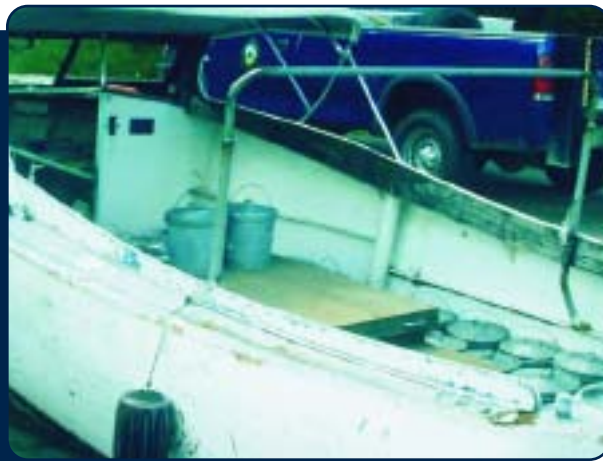
Prior to the composting toilet project, many lakeside residents in Skaneateles relied on a pail pick-up service initiated in 1908 to dispose of their household sewage. Five-gallon pails of raw sewage were transported by truck and boat to Syracuse. Photos by Rich Abbott.

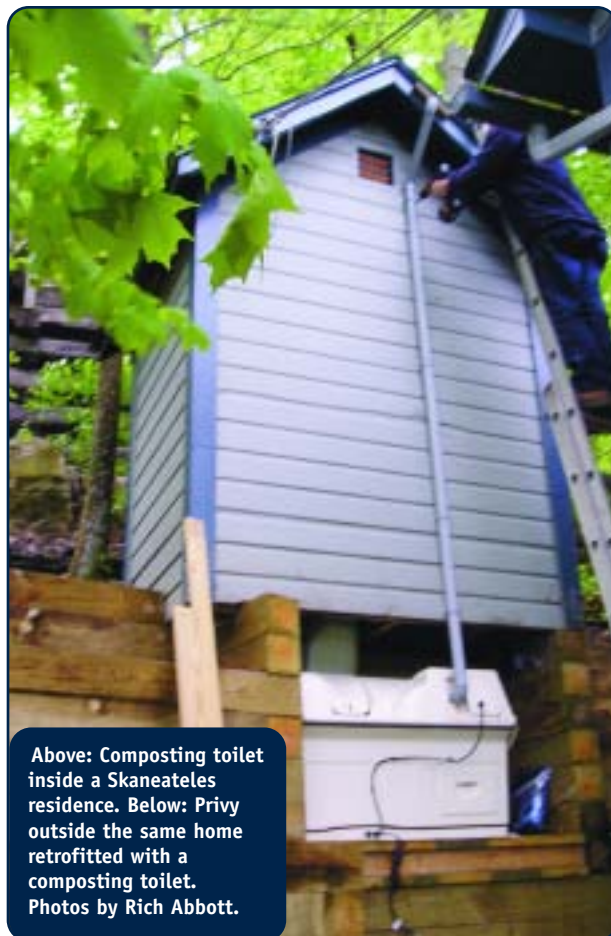
Above: Composting toilet inside a Skaneateles residence. Below: Privy outside the same home retrofitted with a composting toilet. Photos by Rich Abbott.

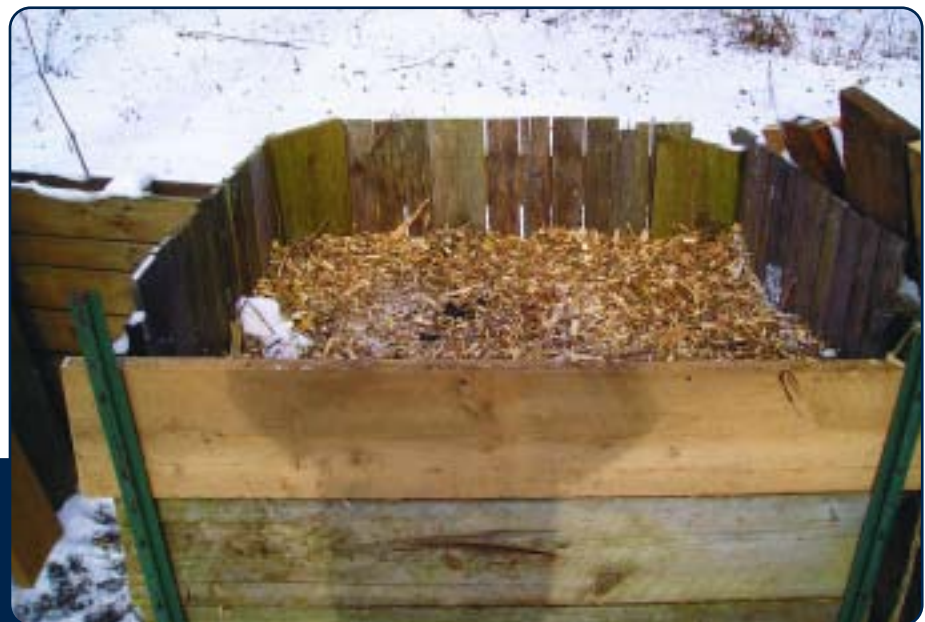
Bin holding finished toilet compost. The compost is combined with fresh grass clippings, hay, and mulch and is allowed to secondary compost. Alternate bins allow compost to age for a minimum of two years. Photos by Rich Abbott.

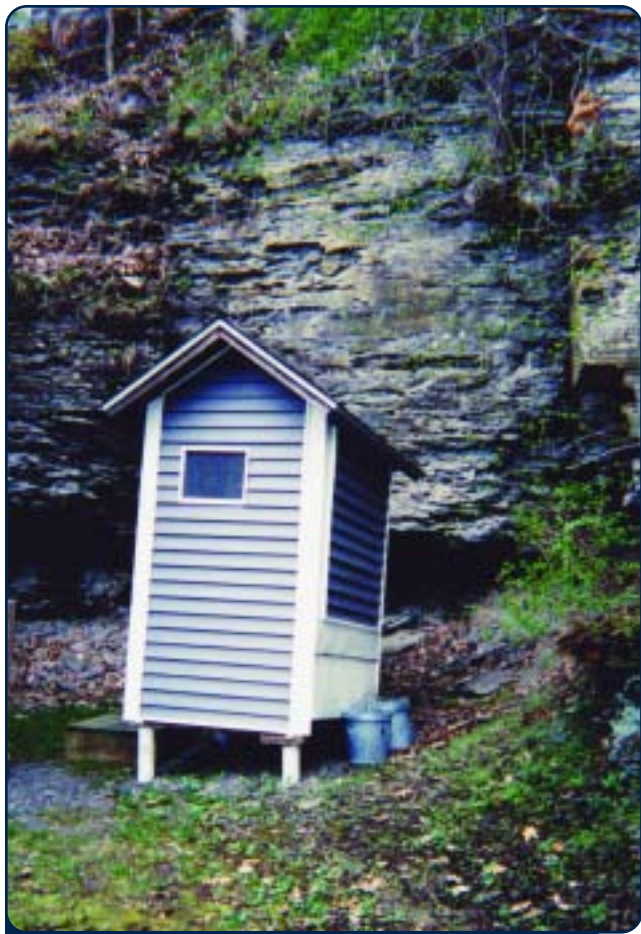
Privy behind a Skaneateles home shows the steep rocky terrain and limited land available for conventional onsite wastewater treatment systems. Photo by Patricia Miller.

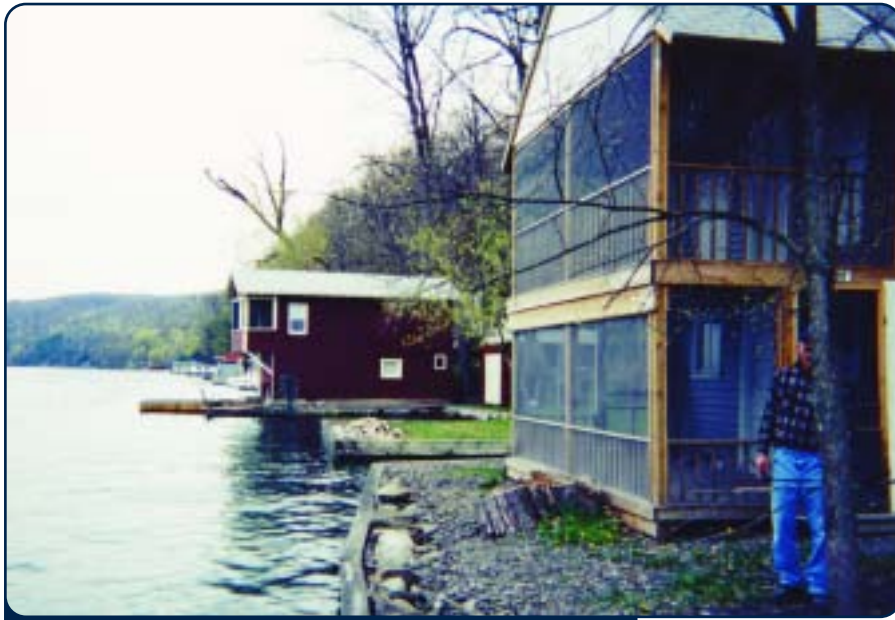
Some Skaneateles homes have been built partially extending out on the lake because of the limited land on the lakefront. Photo by Patricia Miller.
